Reference: 2020 Municipal Separate Storm Sewer System Program Plan and Annual Report for
Virginia Stormwater Management Program Permit No. VA0088587

Fairfax County, Virginia 2020 Municipal Separate Storm Sewer System (MS4) Program Plan and Annual Report

Reporting Period: July 1, 2019 through June 30, 2020

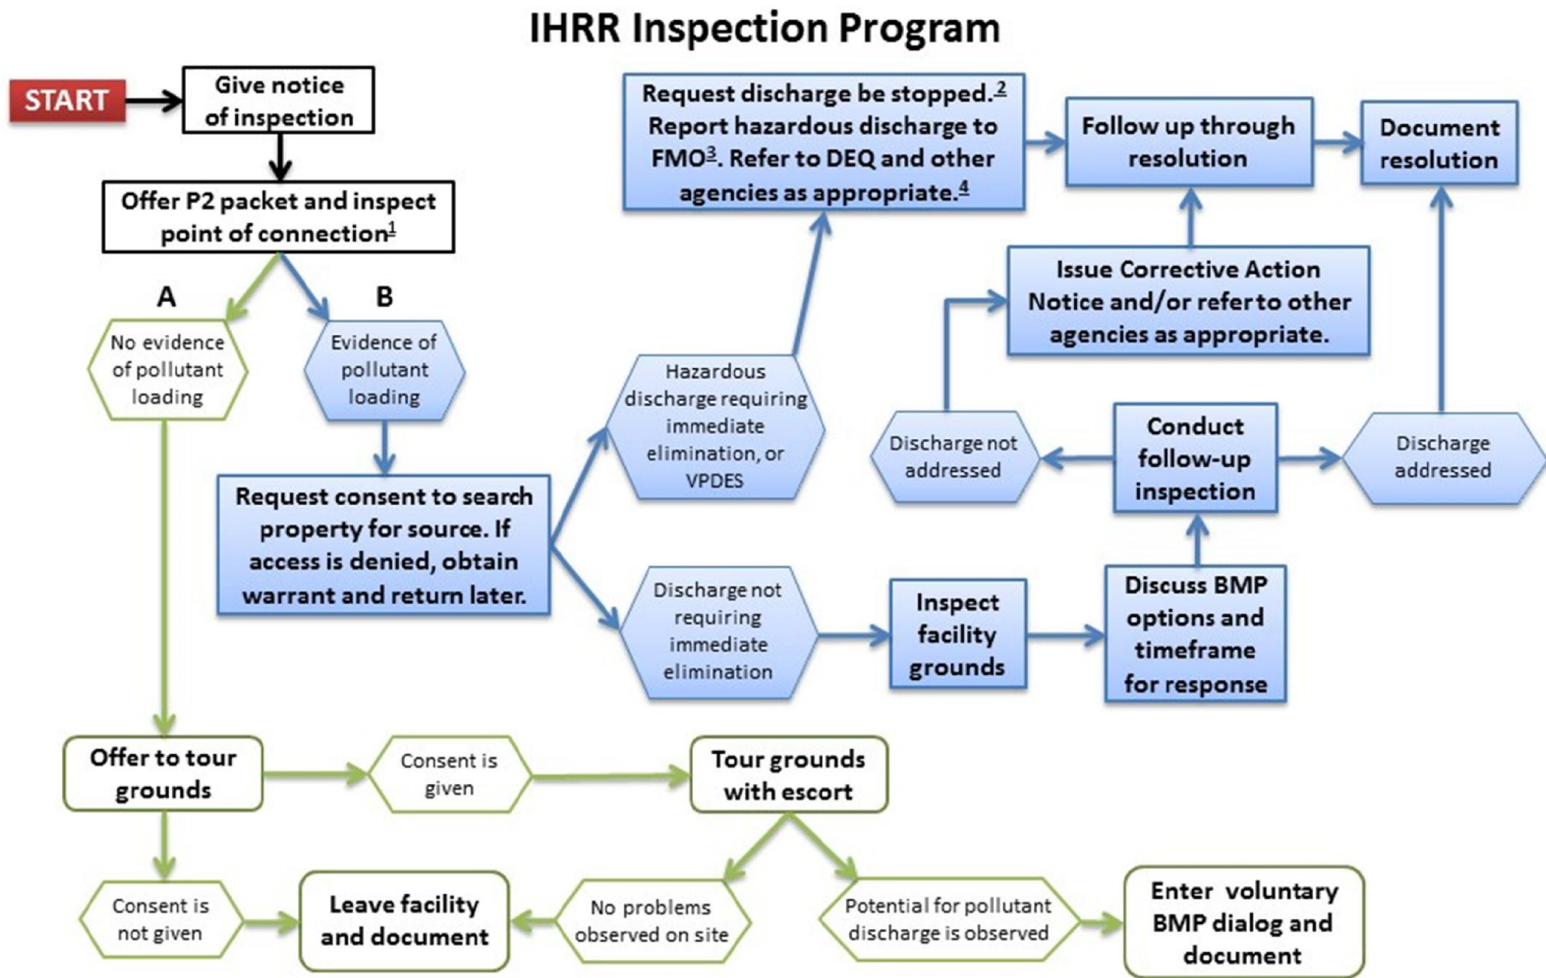
Figure 1: IHRR Program Inspection Process

4. - Conduct atmospheric monitoring using a gas meter before opening any manholes.
5. - If there is any indication before dispatch or upon arriving at the site that hazardous material may be present, contact the Fire Marshal's Office (FMO) immediately to determine if hazardous material is present. Do not proceed with the investigation until the FMO has verified that any hazardous material the FMO screens for is not present.

Notes:
¹ The point of connection is where the facility's discharge enters Fairfax County's MS4.
² SWPD may initiate enforcement of non-VPDES facilities. This could include issuance of a Corrective Action Notice. It could also include coordination with the County Attorney's Office.
³ In all emergency situations involving discharge of hazardous materials, call 911 immediately.
⁴ Any facility with a VPDES permit shall be reported to DEQ when evidence of significant pollutant loading to state waters is found. Notify the MS4 County Facilities Coordinator of significant pollutant loading involving any county facility.

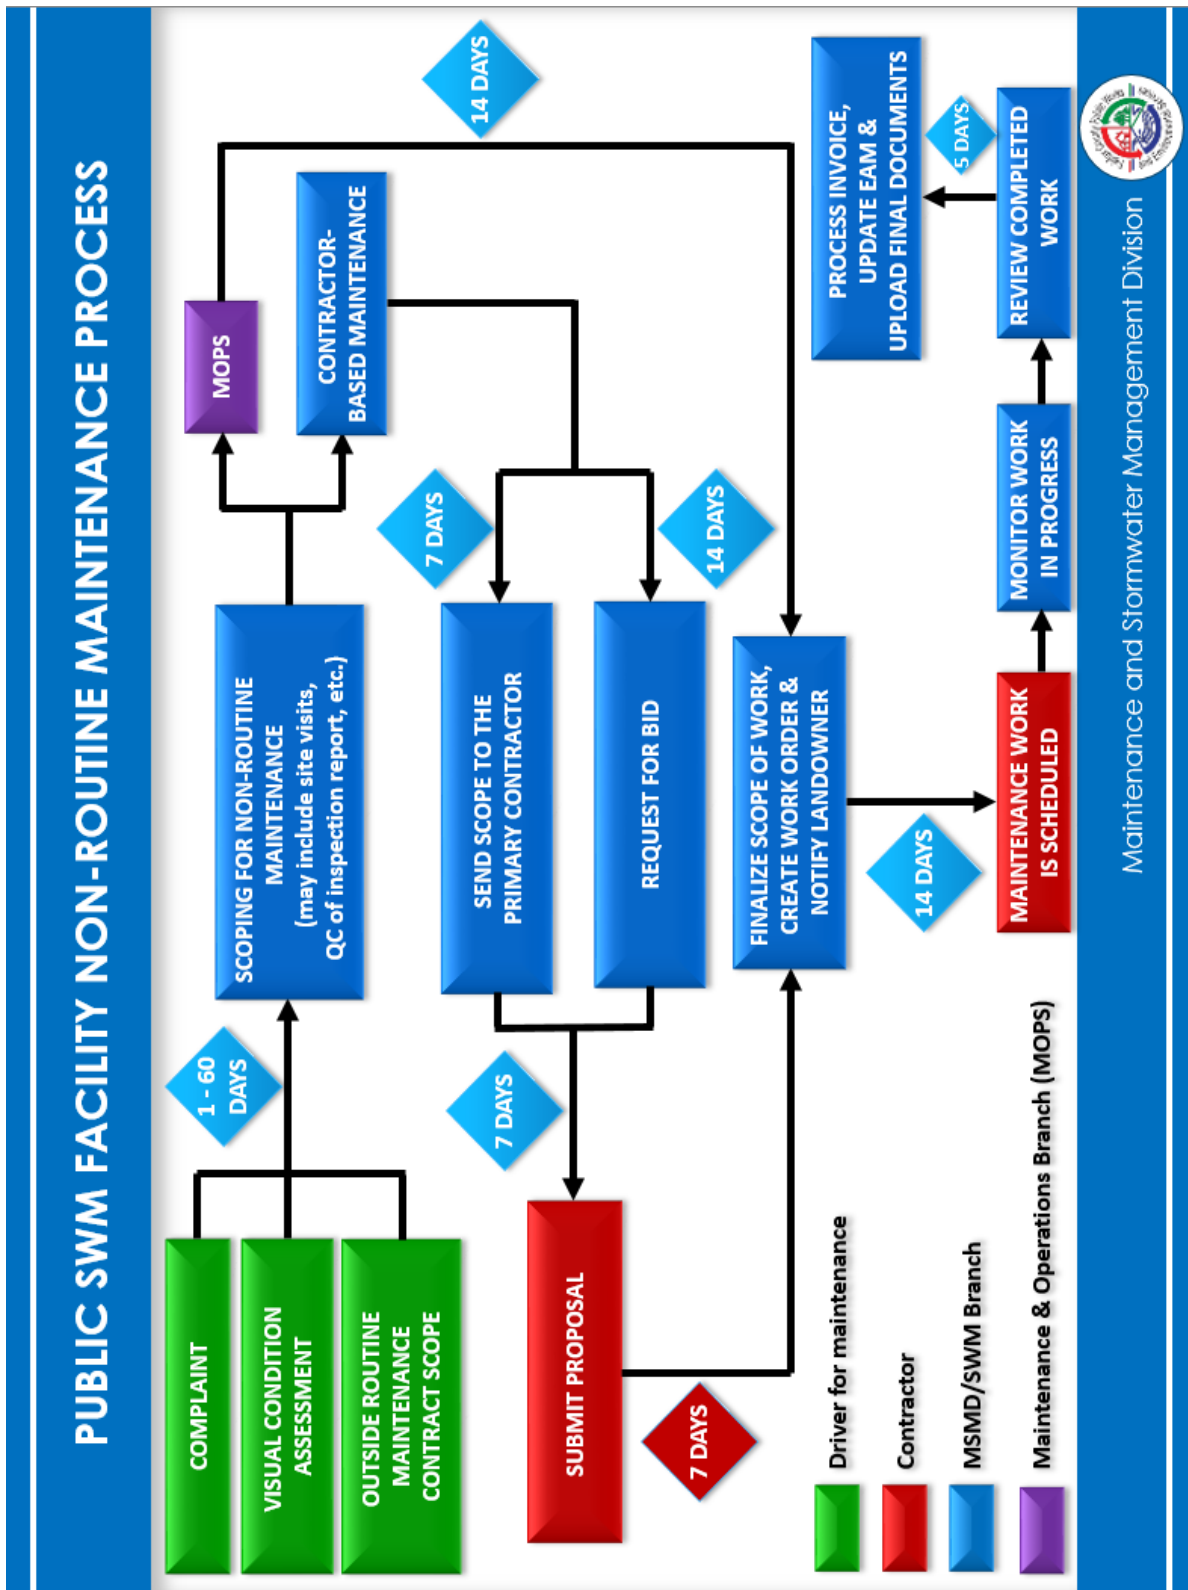
Appendix C – Public Pond Non-routine Maintenance Work Flow Process

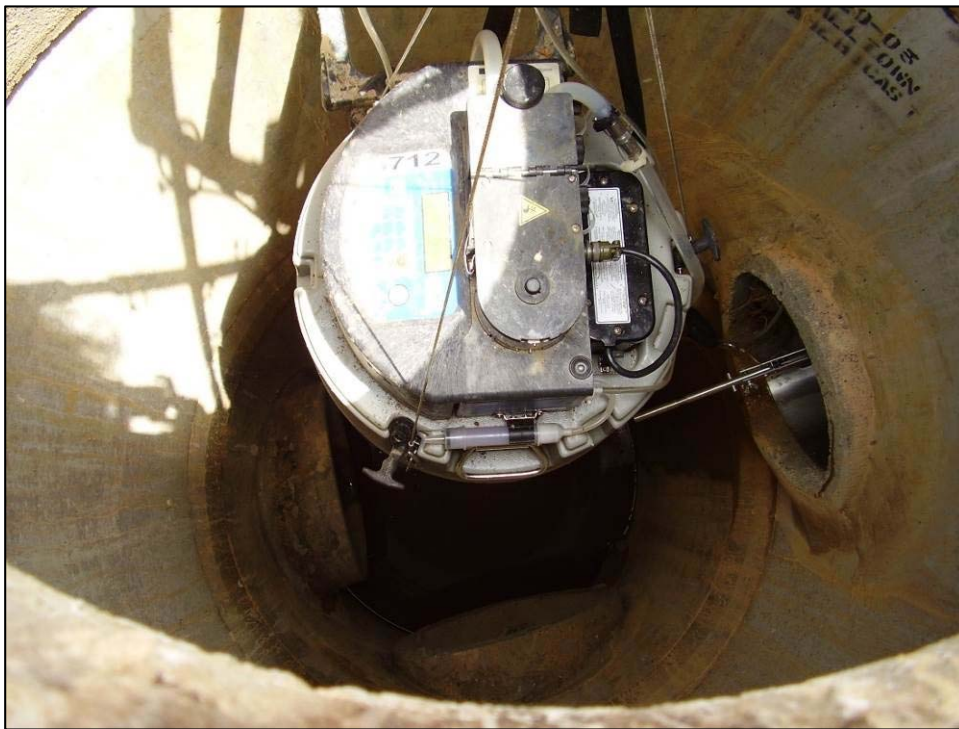
Should site conditions require, an ISCO Model 6712C compact portable sampler may be used. This sampler is of a size and configuration that will allow it to be inserted and retrieved from a manhole and suspended using a pro-hanger and appropriate harness (for manholes 18 to 24 inches in diameter). Alternatively, the samplers may be secured using rebar loops inserted into the ground and combination bicycle locks to discourage theft.

Automated sampler placed in manhole using hanger and spring ring

Attached to all automated samplers will be an ISCO Model 730 bubbler flow module that will log the water flow rate in the pipes of interest. The flow module measures water level within the pipe based on overlying water pressure exerted on bubbles pumped from the module that exit the bubbler tubing at the base of the pipe. Flow rates are calculated from the water level measurements based on Manning's Equation.

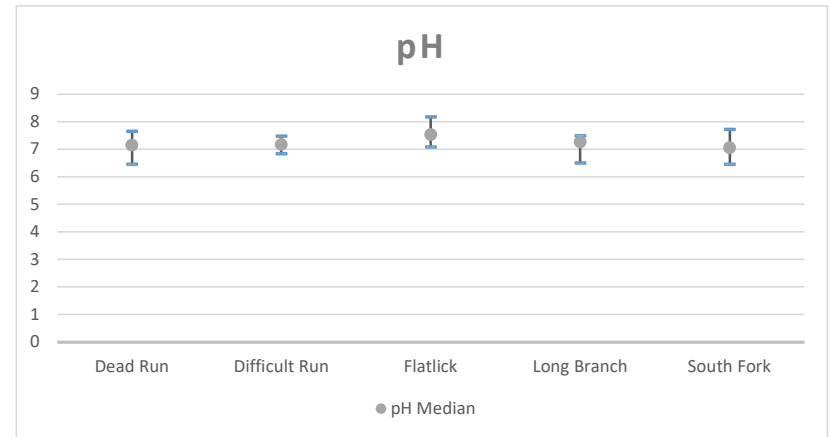
Latitude	Longitude	pH		
			Min	Max	Median
Dead Run	38°57'34.8"	77°10'33.5" NAD27	6.46	7.66	7.16
Difficult Run	38°53'04.5"	77°19'57.8" NAD27	6.84	7.48	7.18
Flatlick	38°52'56.2"	77°25'55.9" NAD27	7.09	8.18	7.545
Long Branch	38°48'39"	77°14'07" NAD27	6.5	7.49	7.275
South Fork	38°54'35"	77°20'14.6" NAD27	6.46	7.72	7.07
